Clean Water State Revolving Fund (SRF) Project Plan

Pittsfield Charter Township

April 19, 2021

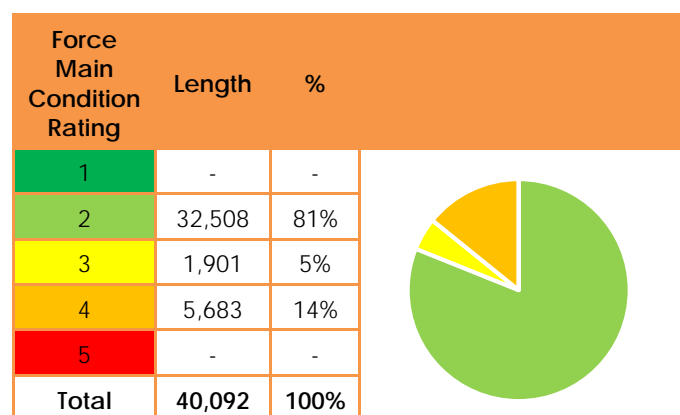
Based on desktop analysis methods, the inspected force mains were found to be generally in fair to good condition. Approximately 86% of the sewer pipes had a condition rating of better than 4. The chart below provides a depiction of the findings:

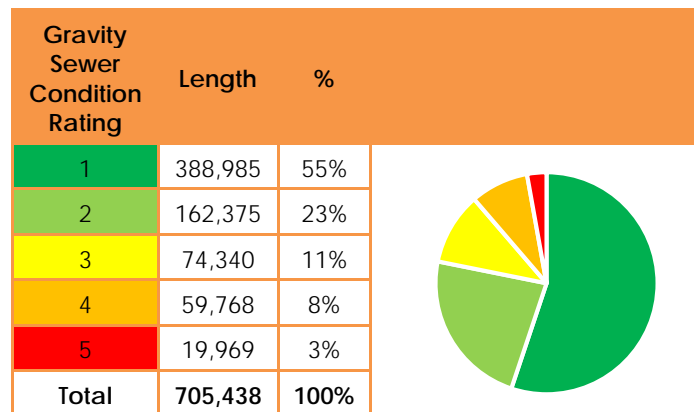
Based on the inspection data collected by the Township staff and the desktop analysis, the inspected sewers were found to be generally in average to excellent condition. Approximately 89% of the sewer pipes had an overall condition rating of better than 4 (PACP Structural and/or Operation and Maintenance categories). The chart below provides a depiction of the findings:

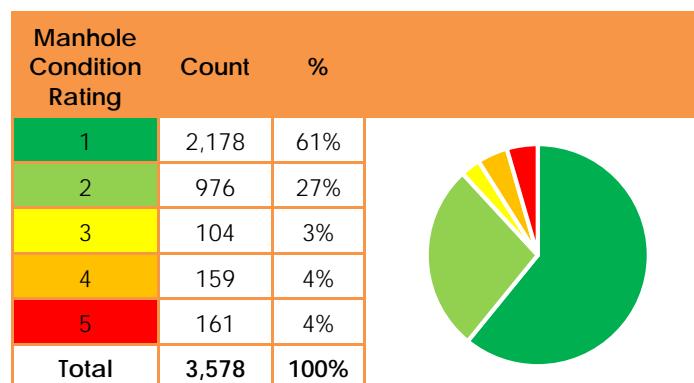
Based on the inspection data collected by the Township staff and the desktop analysis, the inspected manholes were found to be generally in good to excellent condition. Approximately 91% of the manholes had an overall condition rating of better than 4 (MACP Structural and/or Operation and Maintenance categories). The chart below provides a depiction of the findings:

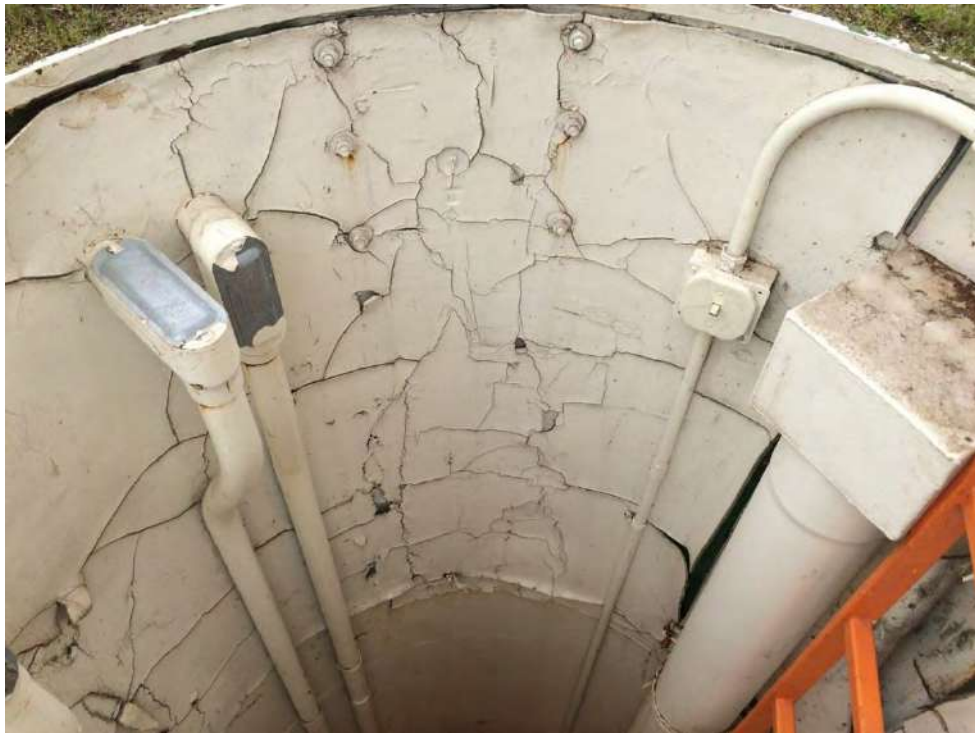
Photo 2: Steel Can Coating System

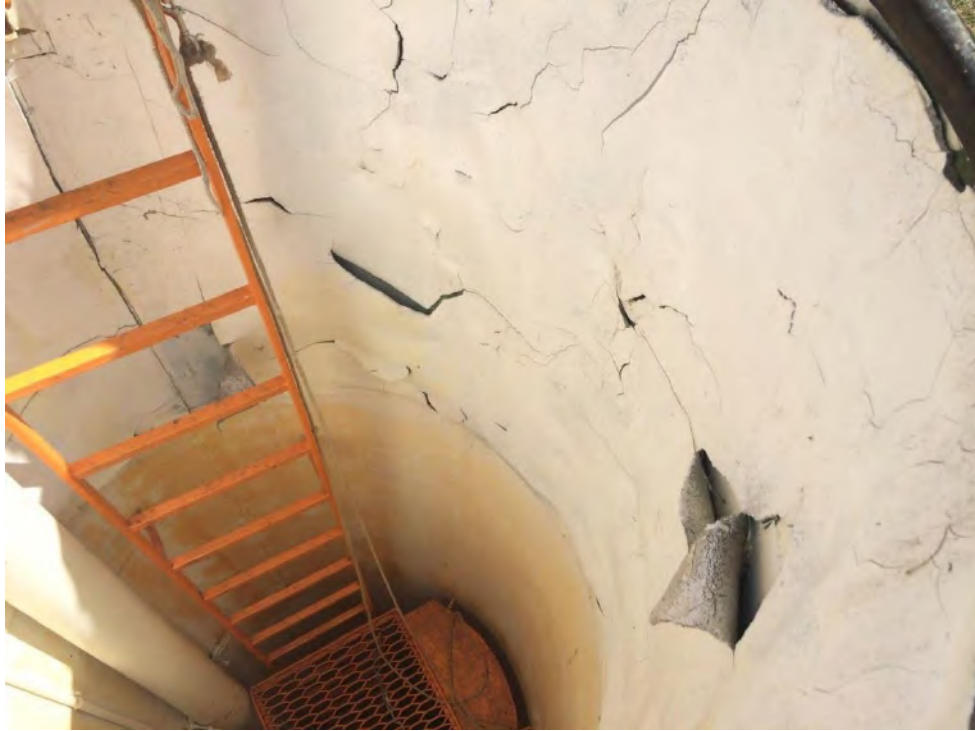
Photo 10: Steel Can Interior Coating System

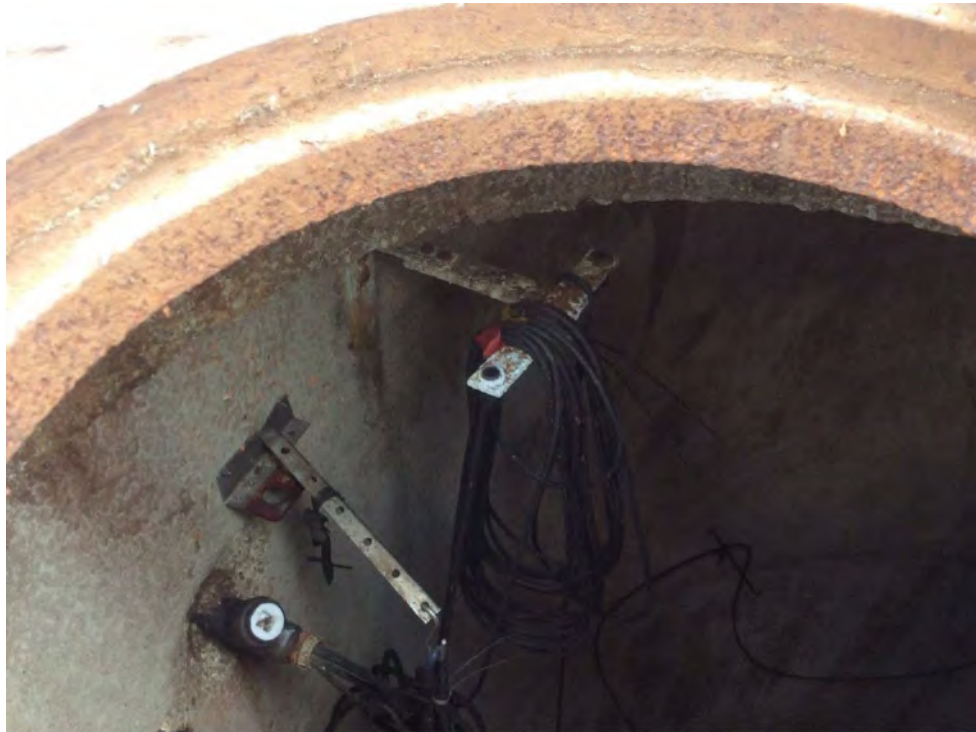
Photo 21: Wet Well Float Rack

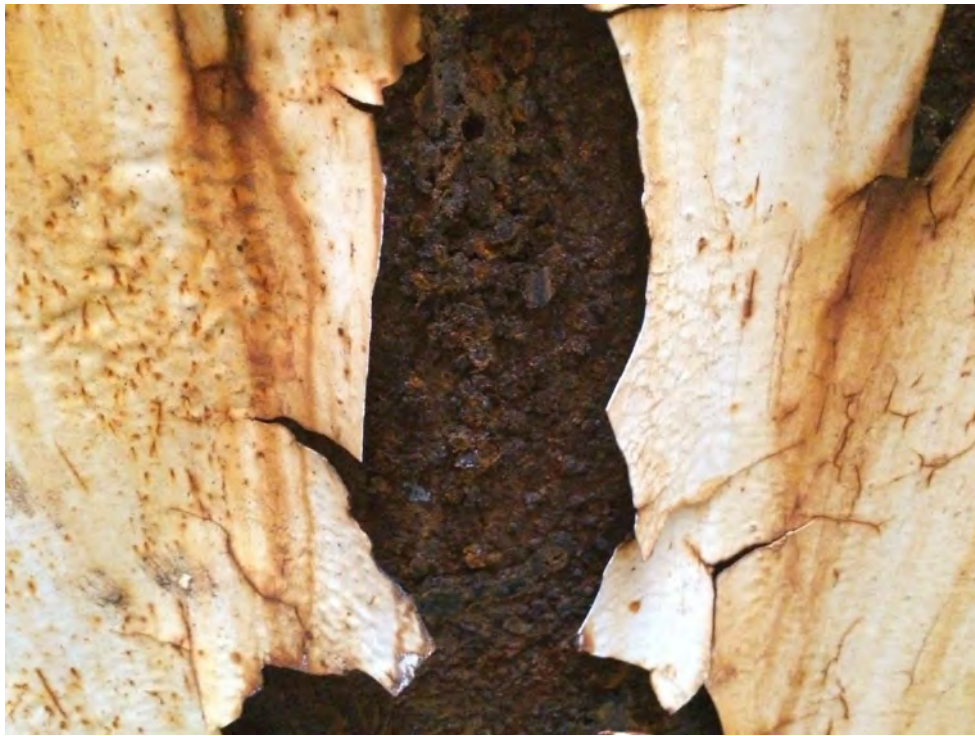
Photo 30: Steel Can Interior Walls

This can style pump station was refurbished in 2007, and all components are well maintained, however, moderate deterioration consistent with the pump station age was noted on most components. Structurally, the steel can exhibit significant oxidation and the wet well has some structural cracking. Per the Township’s AMP, the process and electrical systems are also due for upgrade within the next two to three years.

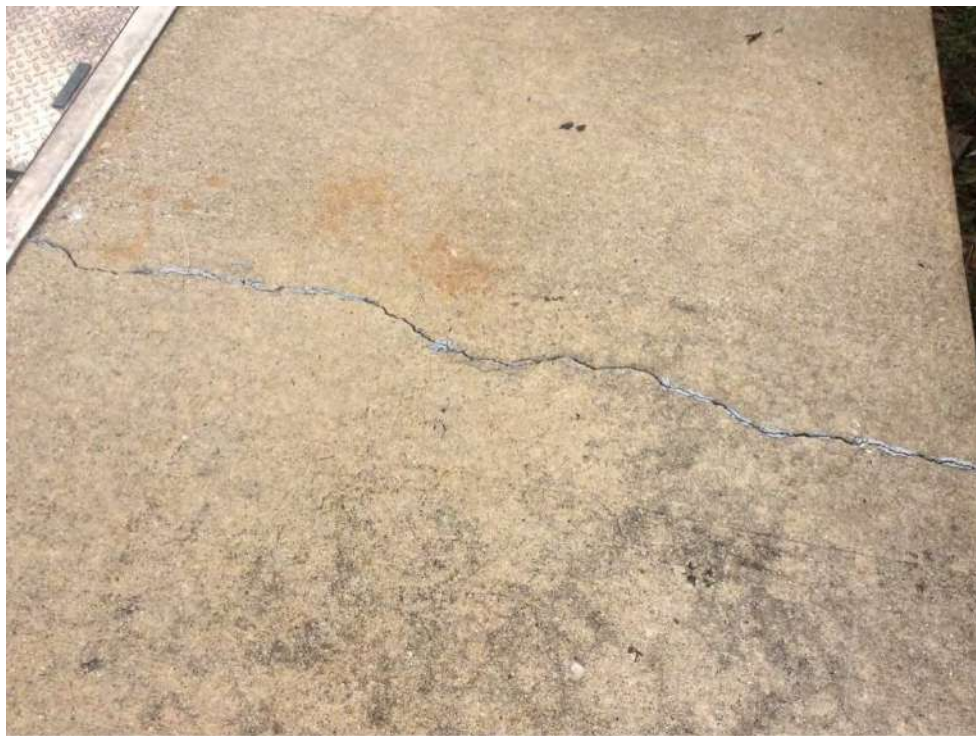
Photo 33: Wet Well Top Slab

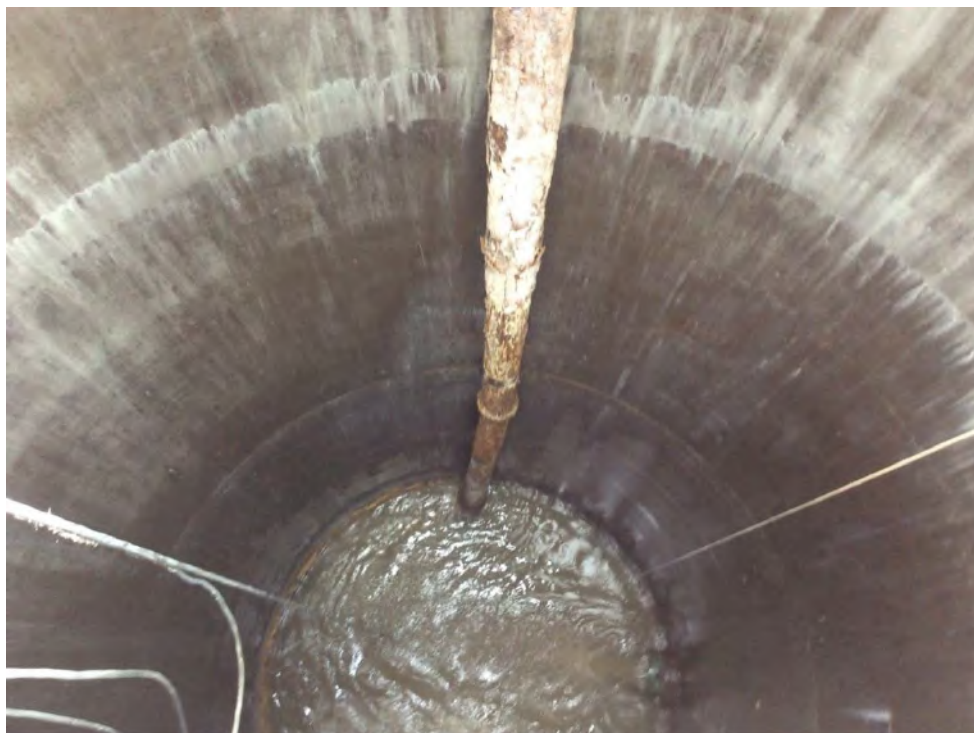
Photo 34: Wet Well Bypass Pump Line
